GEOTECHNICAL ASSESSMENT

THURBER ENGINEERING LTD.

**FUNCTIONAL PLANNING STUDY FOR
HIGHWAY 15:06 TWINNING
(FROM RANGE ROAD 220 TO
HIGHWAY 830 NORTH)
FORT SASKATCHEWAN, ALBERTA
GEOTECHNICAL ASSESSMENT – REVISION 1**

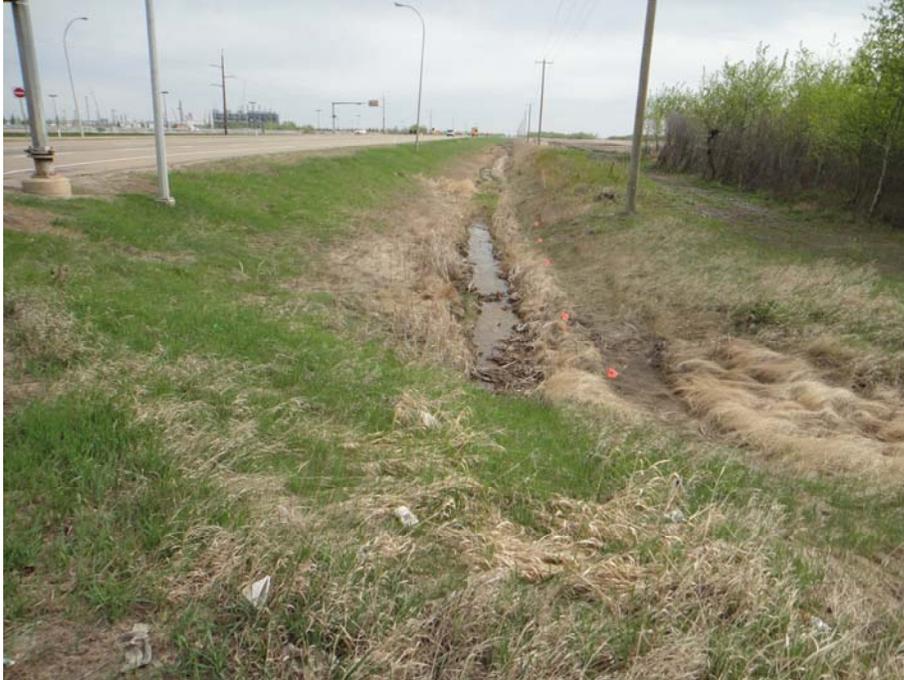
Photo 1 – Vegetation in ditch, looking east along Highway 15 from 125 Street towards Range Road 220

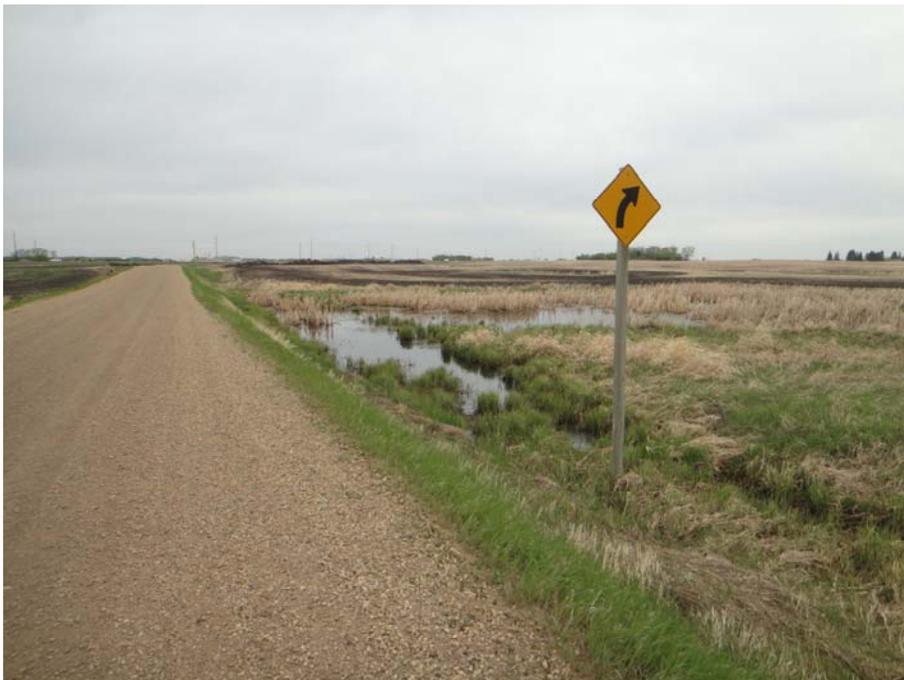
Photo 2 – Standing water along east side of Range Road 220 looking north towards Highway 15

Embankments constructed for both the CNR railway and Highway 15 further limits the flow of surface water. Several small ponds with marsh growth were observed between the railway and the roadway alignments. Small ponds and pools of standing water with marsh growth were also observed at several locations between 125 Street and Range Road 220 on the south side of Highway 15.

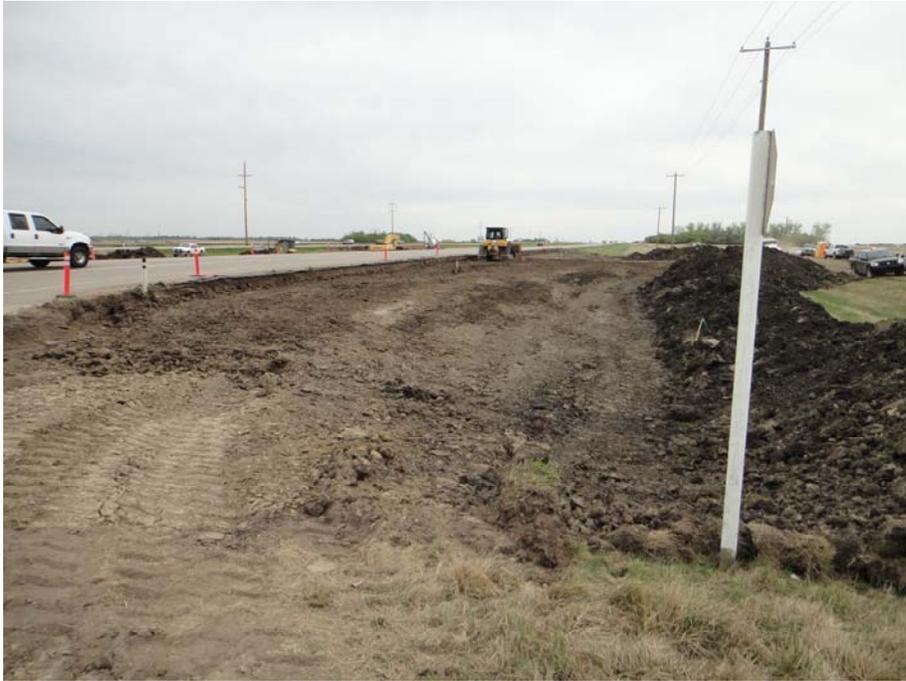
Photo 3 – Active construction at intersection of Highway 15 and Range Road 220.

- At the time of the site reconnaissance, grading activities were underway at the intersection of Highway 15 and Range Road 220. Grading and earthworks were being performed to reconfigure Range Road 220 and the associated service road south of Highway 15. Range Road 220 north of Highway 15 had been reconstructed and widened, but was not yet paved at the time of the site visit. Earthworks were also being performed in the median of Highway 15, apparently for the construction of separate left turning lanes.

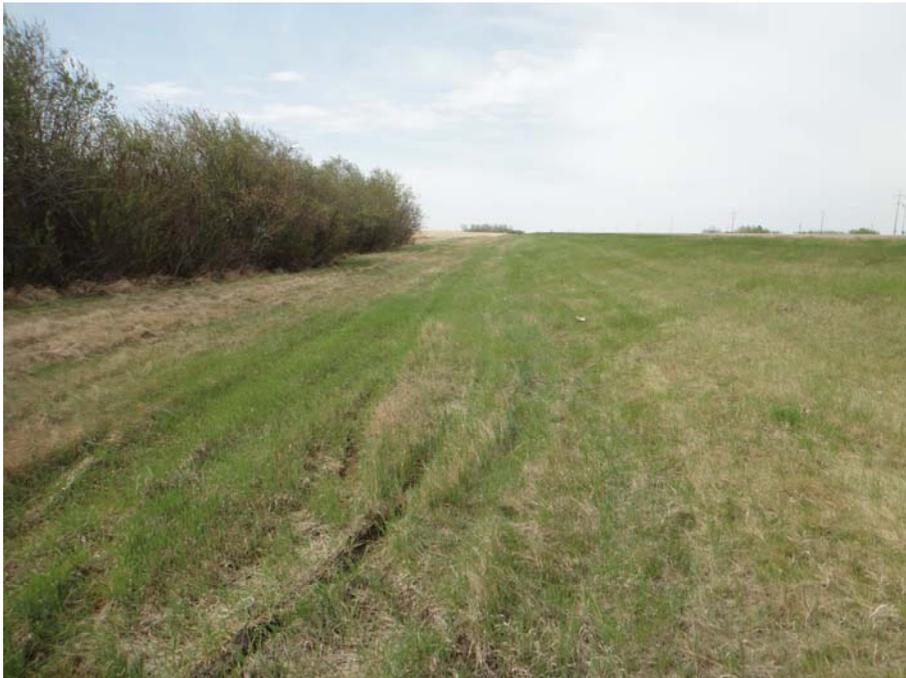
Photo 4 – Looking west along embankment on south side of Highway 15 at Range Road 215

The existing Highway 15 embankments were generally 1 to 3 m in height, with sideslopes inclined at 3H:1V to 6H:1V. The embankment slopes were generally in good condition, and no major erosion features or instabilities were observed. Towards the western limit of the study area, some ponding water was observed in the road side ditches. Along the divided section of the highway, several small diameter CSP culverts connecting the median ditch to the drainage ditch on the south side of the road were observed. Some of these culverts were partially blocked by sediments.

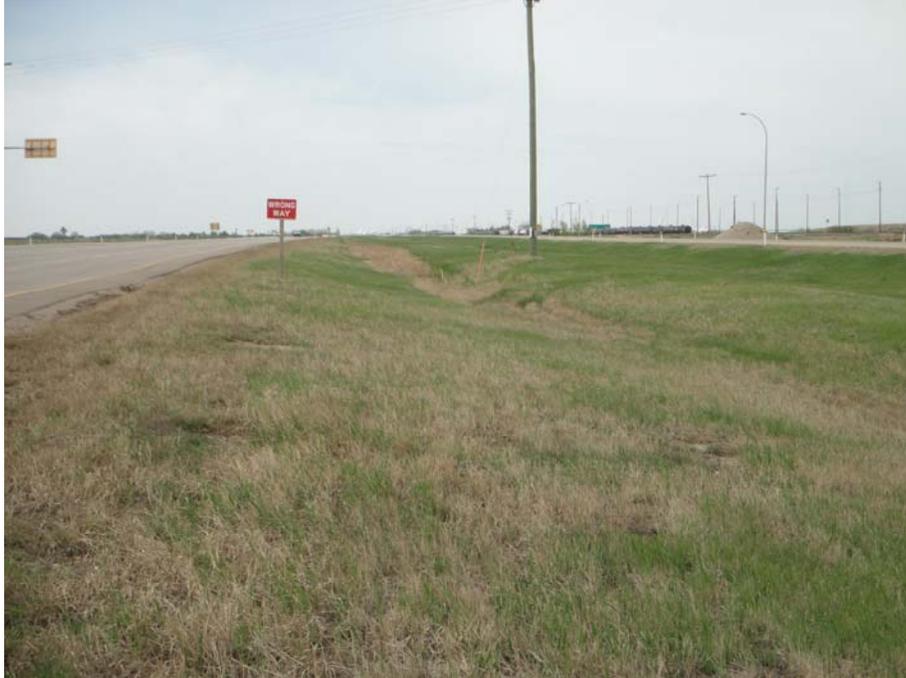
Photo 5 – Median sideslope conditions, looking west from intersection at Range Road 214

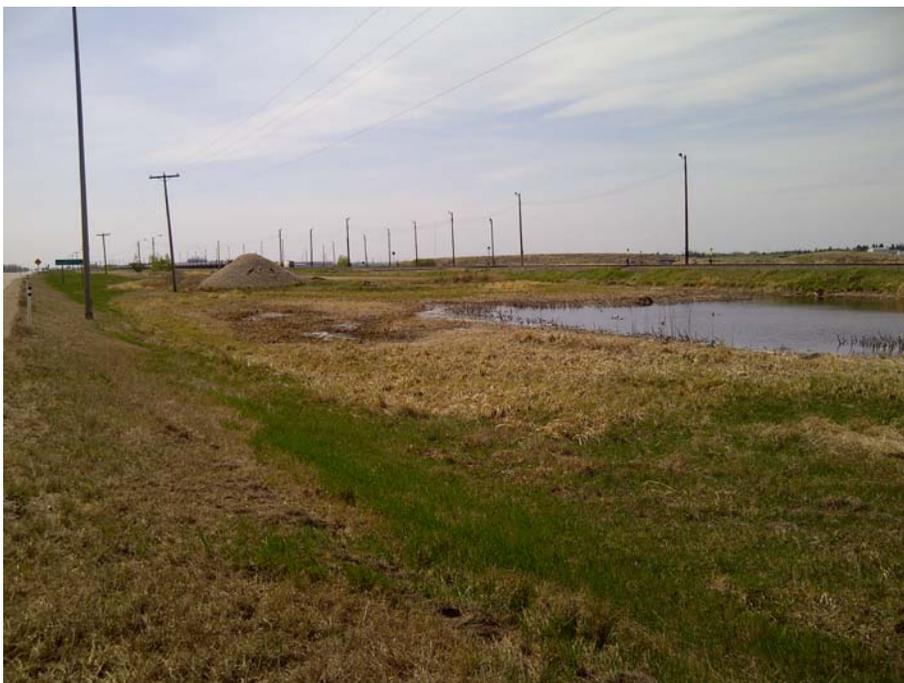
Photo 6 – Standing water and poor drainage between north embankment of Highway 15 and parallel CNR railway, looking west from the intersection with Range Road 220

As discussed in Section 5.1.2, drainage conditions in the central and western portions of the study area were generally poor. Past experience has shown that poor road performances are attributed, in many cases, to poor drainage. Hence, the design of the proposed road must incorporate an adequate drainage system capable of collecting and directing surface runoff away from the roadway. This could include the use of proper crossfall slopes (at least 2%) on both the subgrade and pavement surfaces, the installation of drainage culverts to facilitate the flow of water and minimize ponding near roadway embankments, and the positive grading of drainage ditches towards relief points away from the roadway.

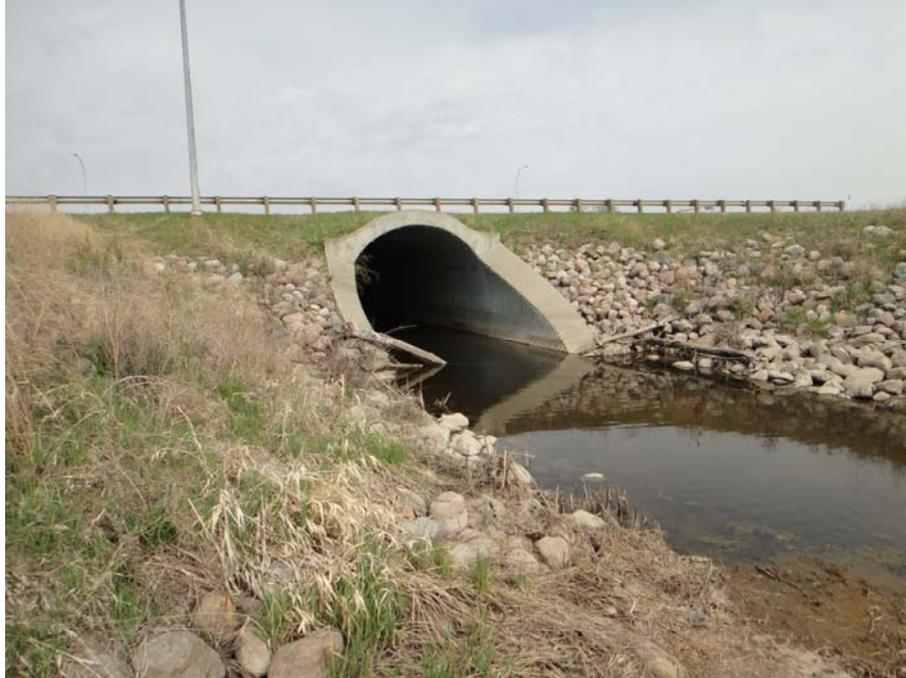
The stream is channeled beneath Highway 15 via a 5.5 m diameter, structural steel plate culvert (eastbound lanes), and a dual opening, concrete box culvert (westbound lanes). Both structures were approximately 30 m in length. The fill cover above the crown of the two culverts was approximately 1.5 m thick. Both structures appeared to be in good condition.

Photo 7 – CSP culvert beneath eastbound lanes of Highway 15 at Astotin Creek – BF73649

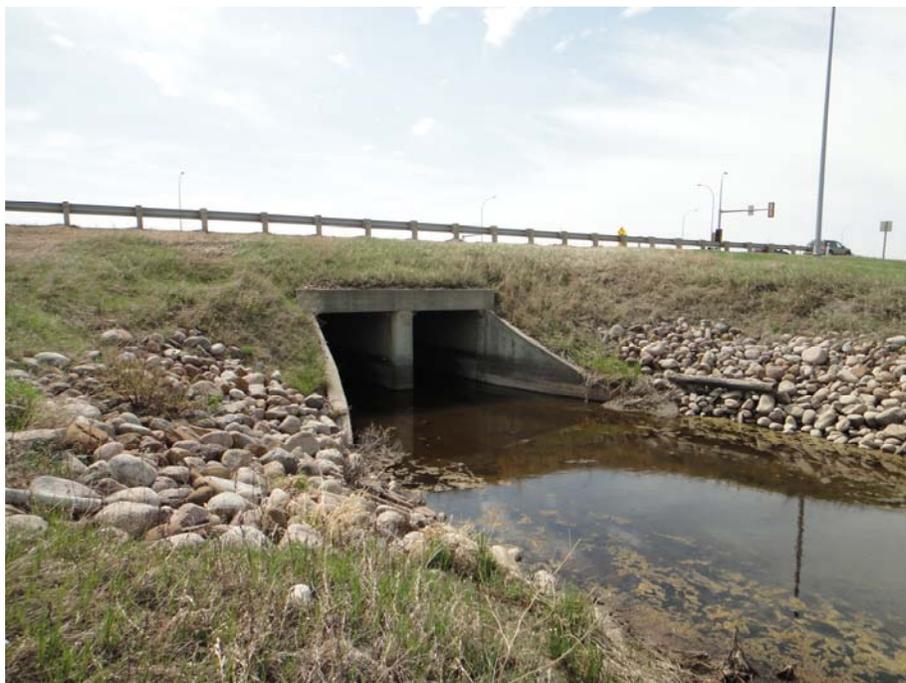
Photo 8 – Double box culvert beneath westbound lanes of Highway 15 at Astotin Creek - BF73649

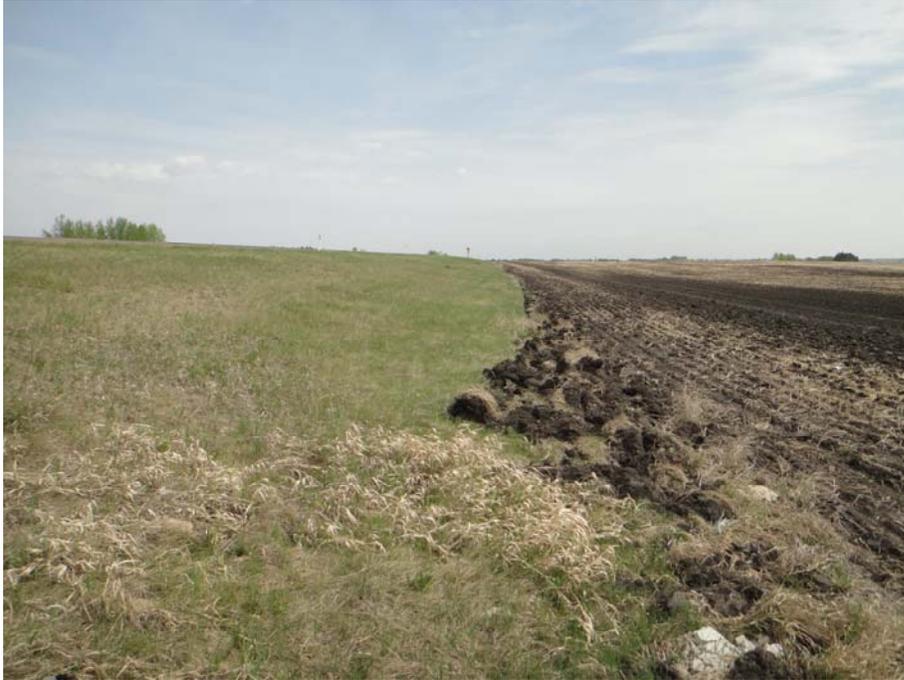
Photo 9 – Typical embankment conditions, looking east between Range Roads 214 and 213

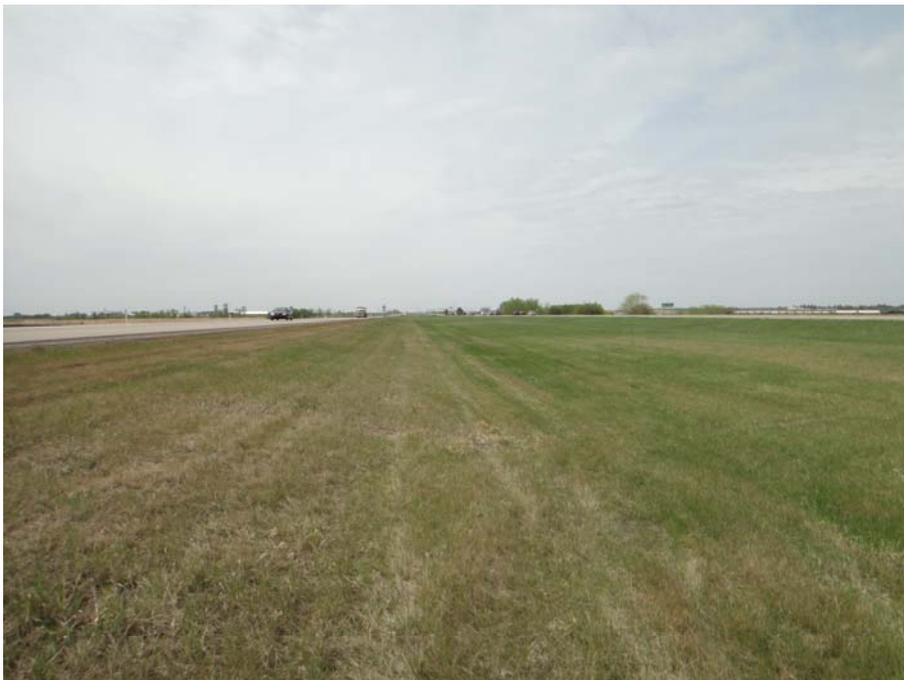
Photo 10 – Typical median conditions, looking west between Range Roads 214 and 213

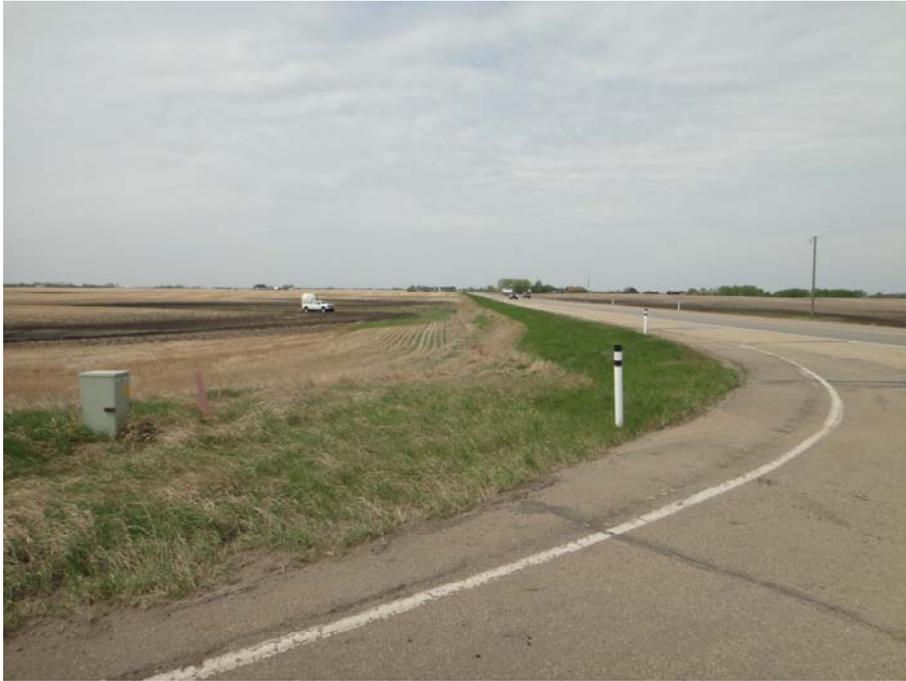
Photo 11 – Typical embankment conditions, looking west at Range Road 212

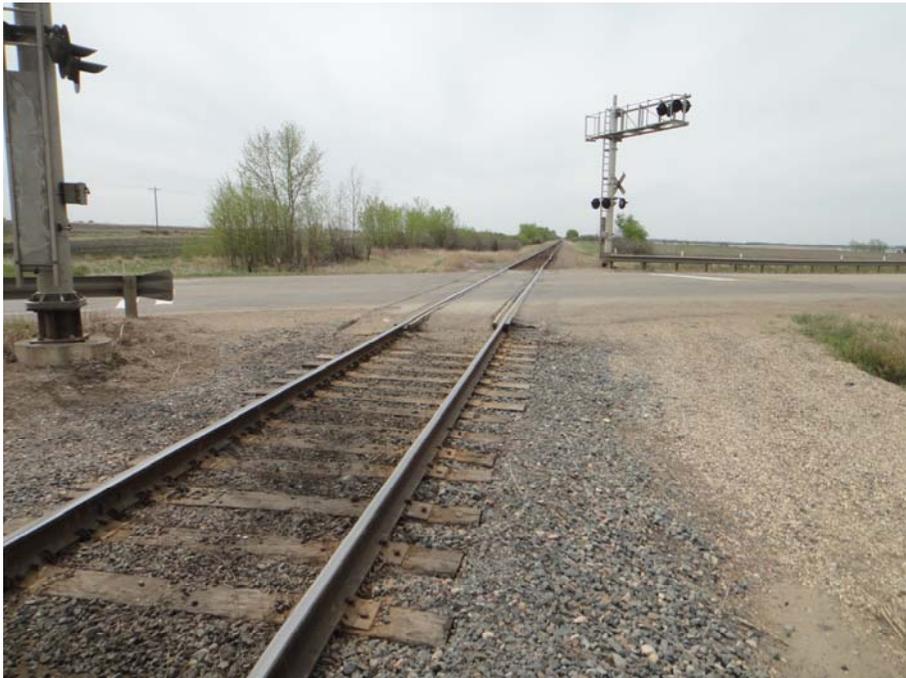
The existing asphalt pavement of Highway 15 within the study area appeared to be in good condition. No areas of excessive pavement distress were observed. Some longitudinal and transverse pavement cracks were noted in the vicinity of the CPR railway crossing east of Range Road 211.

Photo 12 – CPR railway crossing 30700, east of Range Road 211
