YELLOWHEAD NORTH ARTERIAL ROAD FUNCTIONAL DESIGN STUDY

Appendix D – Environmental Overview Update

AN ENVIRONMENTAL UPDATE FOR THE YELLOWHEAD NORTH ARTERIAL ROAD FUNCTIONAL DESIGN STUDY

May 2009

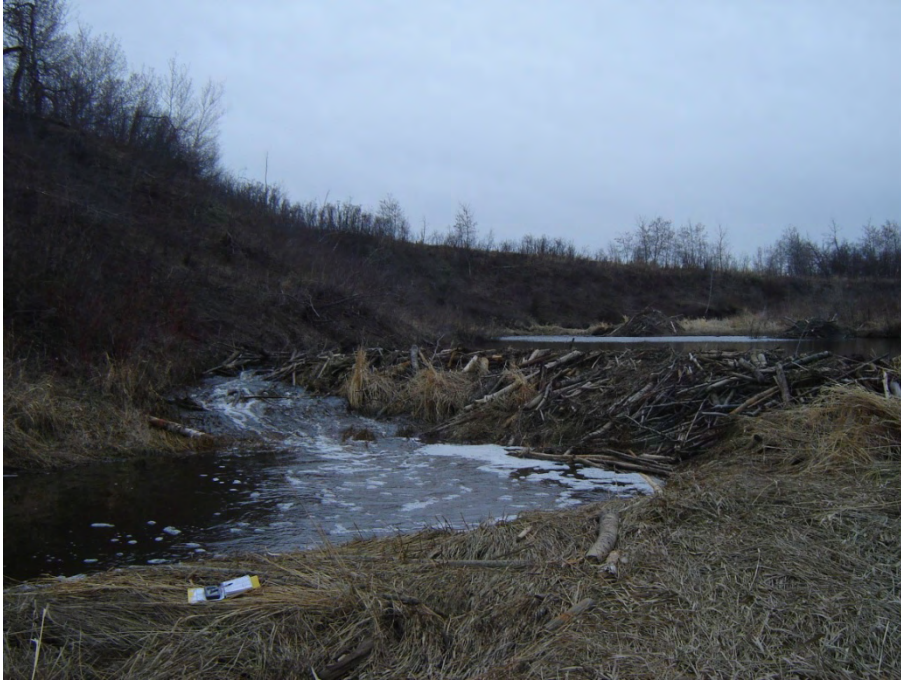
Oldman Creek in the vicinity of Crossing 1 was characterized entirely as beaver impounded habitat with a low and consistent slope over a primarily silt-based channel substrate. In this area, the channel was occasionally confined and the silt-based banks were unstable at several locations. At the proposed crossing location, the creek had a wetted width of 3.5 m, a mean depth greater than 1.5 m, and a mean velocity of 0.7 m/s (Table 1). At the time of assessment, Oldman Creek was in runoff and the creek was flowing at bank full depth. The west bank area was stable with a slope of 15° and a height of 0.9 m, while the east bank was moderately unstable with a slope of 80° and a height of 2.0 m (Photos 1 and 2). The habitat at this location was entirely impounded and the substrate consisted of 100% silt. The only exception to the beaver impounded state of the study area was at Transect 5, which was located immediately downstream from a rail line crossing. Upstream from the crossing, a fence had been constructed across the stream to prevent beavers from damming the culvert inlet (Photo 3). The creek flowed through the culvert then was characterized by riffle and run habitat for roughly 100 m before becoming impounded once again. Within the study area, the left bank ranged in height from 0.1 m to 2.0 m and in slope from 15° to 90°, while the right bank ranged in height from 0.1 m to 2.0 m and in slope from 40° to 90° (Table 1).

Photo 1. South (upstream) view of the creek channel and banks at proposed Crossing 1. Note the beaver dam that occurs in the study area.

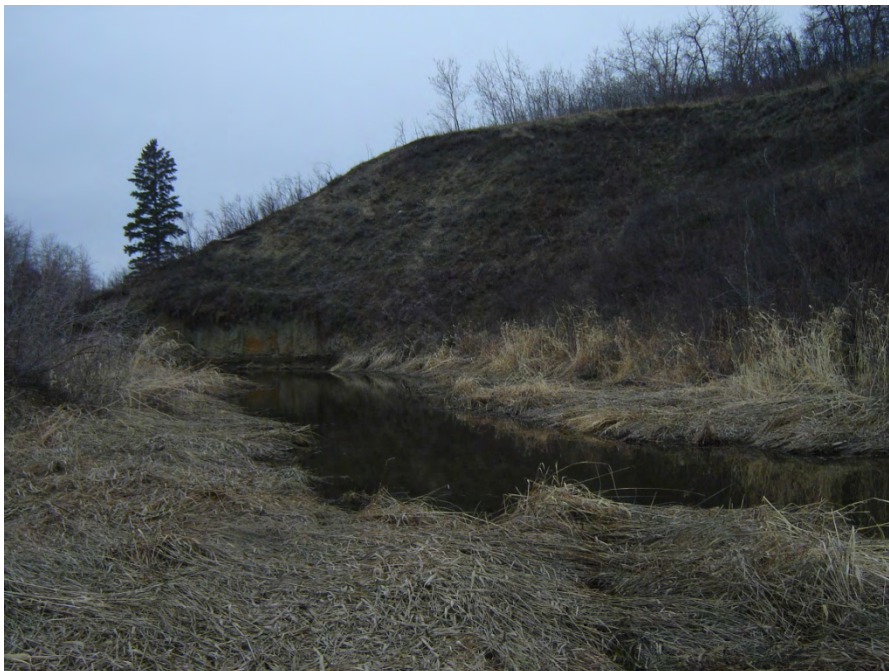
Photo 2. North (downstream) view of the creek channel and banks at proposed Crossing 1. Note the creek flowing at bank full depth.

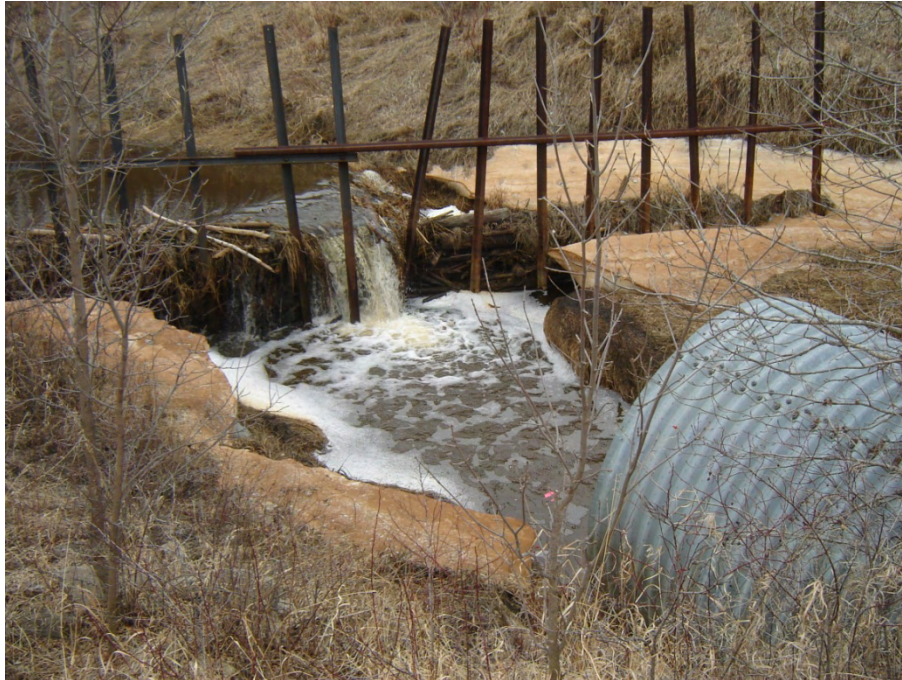
Because of the presence of numerous beaver dams and the heavily impounded nature of the creek in the vicinity of the proposed creek crossing, the potential for migration in this portion of the system was considered to be poor. Migration would be most likely during the spring freshet, but this would be greatly inhibited by beaver activity.

Photo 3. South (upstream) view of a beaver dam at a rail line crossing, located approximately 220 m downstream from proposed Crossing 1.

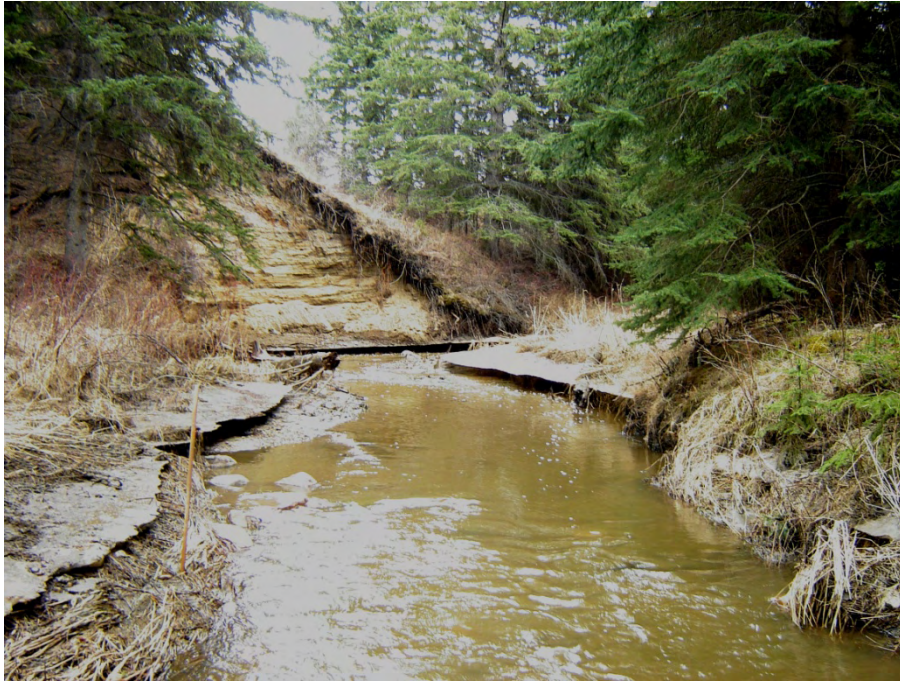
At Crossing 2, Oldman Creek was characterized by diverse habitat features including riffles, runs, and pools, with an irregular meander patterned channel composed of varying combinations of substrate material. In this area, the channel was occasionally confined, partially coupled, and the banks were typically stable. Within the study area, the left bank ranged in height from 0.1 m to 1.1 m and in slope from 25° to 65°, while the right bank ranged in height from 0.1 m to 0.85 m and in slope from 30° to 80° (Table 3). At the proposed crossing location, the creek had a wetted width of 2.3 m, a mean depth of 0.24 m, and a mean velocity of 0.17 m/s (Table 3). The south bank area was stable with a slope of 25° and a height of 0.3 m, while the north bank was moderately unstable with a slope of 80° and a height of 0.85 m (Photos 5 and 6). The habitat at this location was entirely run and the substrate consisted of 70% fines, 20% gravel, and 10% cobble.

Photo 4. East (upstream) view of the creek channel and banks at the proposed Crossing 2 location.

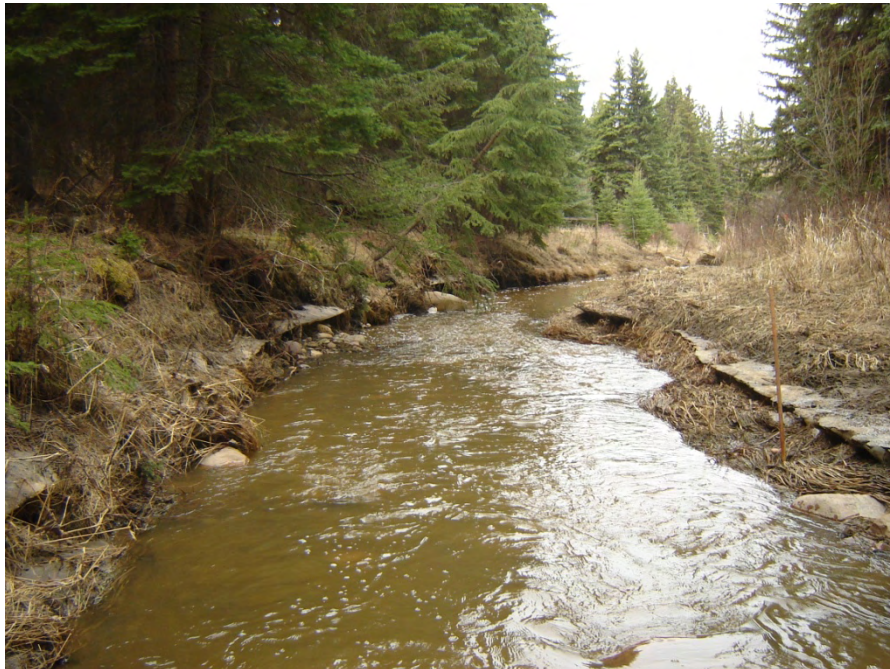
Photo 5. West (downstream) view of the creek channel and banks at the proposed Crossing 2 location.

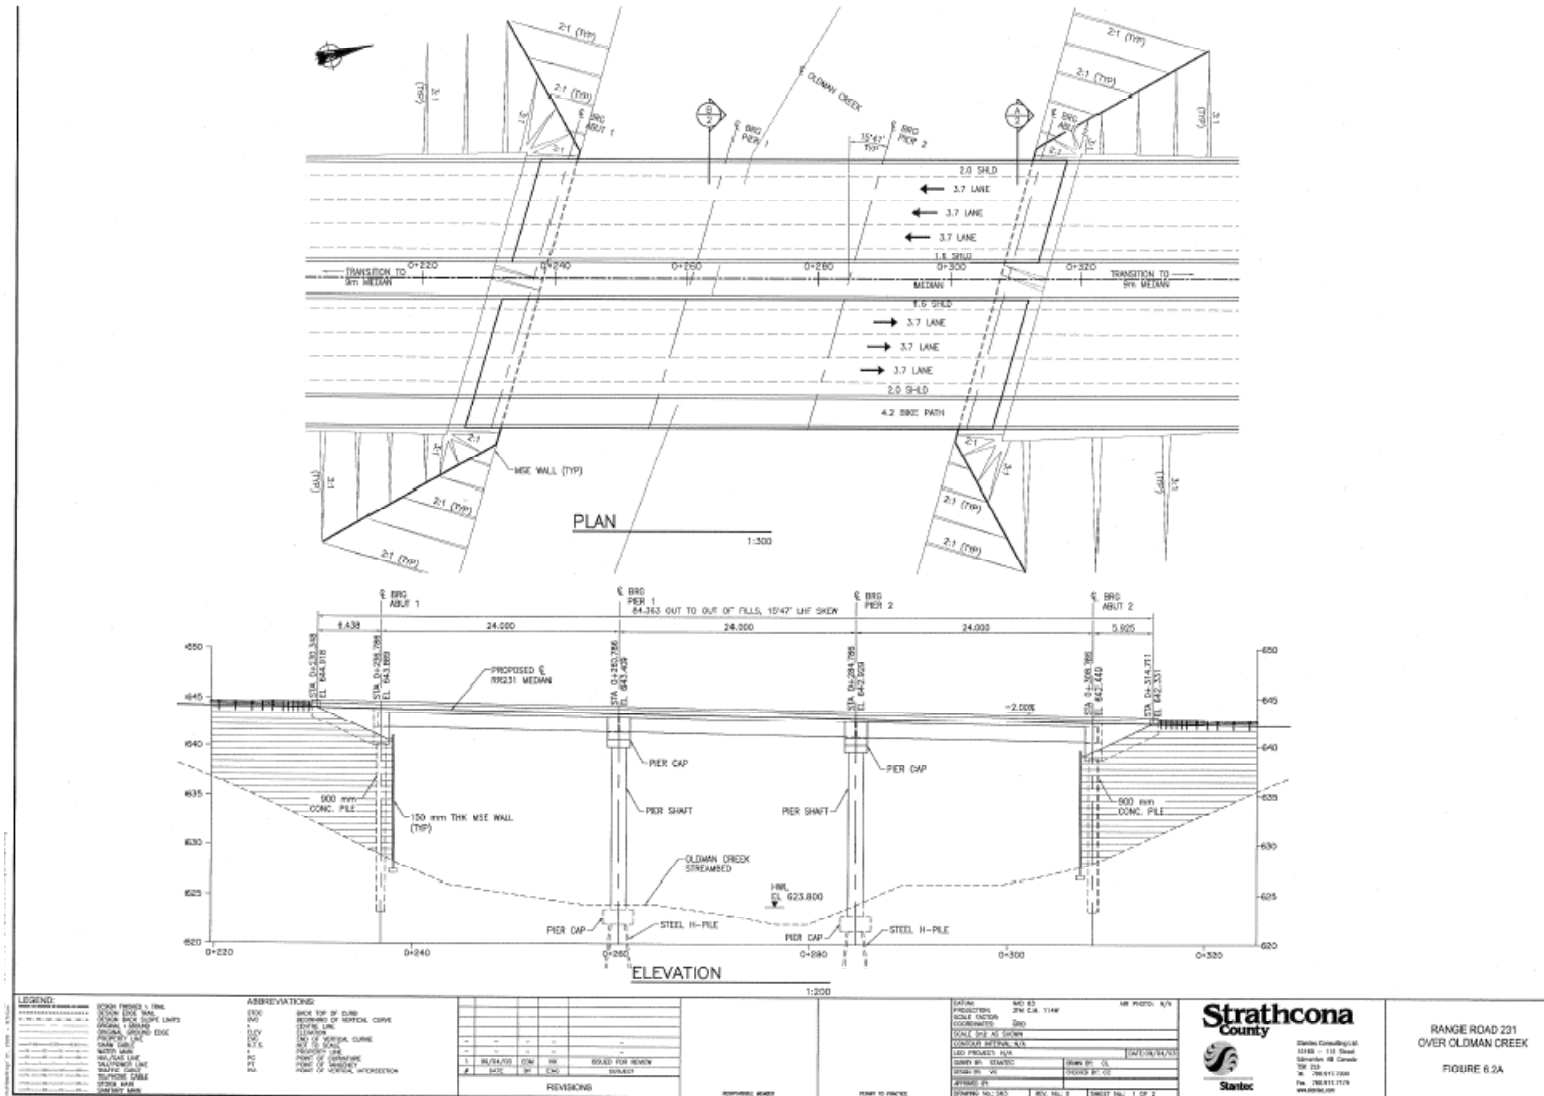
Appendix 2. Engineering plans for the bridge structure at Crossing 2 on Oldman Creek.

The second crossing of the Oldman Creek occurs south of the existing Twp Rd 534 and will include twin structures for the accommodation of staged road widening. Each structure will include a single-span 32 m long bridge. Wildlife passage is provided for under the exterior span and the width of the bridge will accommodate high level water and allow for construction of the crossing in the dry.
